ASSISTANCE OF A STATE DEPARTMENT OF
TRANSPORTATION TO A RAILROAD IN
SOLVING SOILS AND FOUNDATION PROBLEMS

Harry E. Schultz,
Assistant Chief Engineer of Staff,
Delaware and Hudson Railway Company

Stephen E. Lamb,
Senior Soils Engineer,
New York State Department of Transportation

ASSISTANCE OF A STATE DEPARTMENT OF TRANSPORTATION
TO A RAILROAD IN SOLVING SOILS AND FOUNDATION PROBLEMS

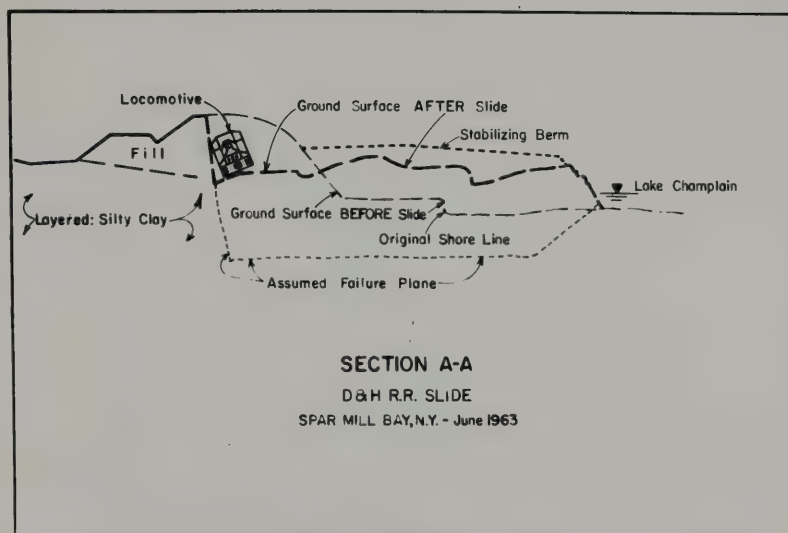
FIGURE 2

The first embankment failure problem occurred in 1963 involving a twenty foot high embankment located near the shore of Lake Champlain. Several days prior to the major failure, maintenance crews had repaired minor track settlement at the site. Additional settlement must have occurred, since the next day a northbound freight was derailed scattering numerous cars along the track north of the future failure area. A work train was sent to the site, cleared the tracks, and unfortunately backed off onto the unstable embankment settlement area while waiting for orders. Suddenly, the embankment and locomotives dropped twenty feet and simultaneously the bottom of Lake Champlain 150 feet distant rose 12 feet above the water. The details of this unusual failure are shown in

CROSS SECTION OF D&H R.R. SLIDE
SPAR MILL BAY, N.Y.
JUNE 1963

Soils engineers in the DOT were contacted for an appraisal of the failure and recommendations for restoration of the embankment in order to reestablish main line service. Inspection indicated that the area was underlain by a layered silt and clay deposit and the topography of the adjacent hillsides showed evidence that this was an area of ancient landslides. It was concluded that the initial settlements observed were caused by minor movements in the underlying clay. Although the embankment had been stable for thirty years, high groundwater conditions may have caused minor plastic movements in the foundation soil that contributed to the settlement that caused the derailment. However the major movement was caused by the weight of the locomotives and the vibrations generated by the idling engines. These vibrations apparently caused liquefaction and complete loss of strength in an underlying silt layer that resulted in the spectacular failure. Recommendations were to construct a stabilizing counterweight berm over the mudwave to the elevation shown in Figure 2. After the berm was completed the embankment was brought back to grade. This was done in two days and the area has presented no problem during the last 14 years.

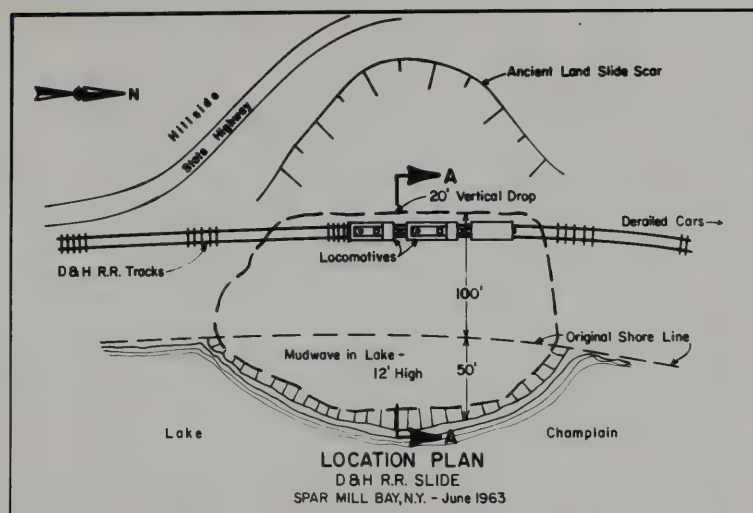
FIGURE 3

PLAN OF D&H R.R. SLIDE
SPAR MILL BAY, N.Y.
JUNE 1963

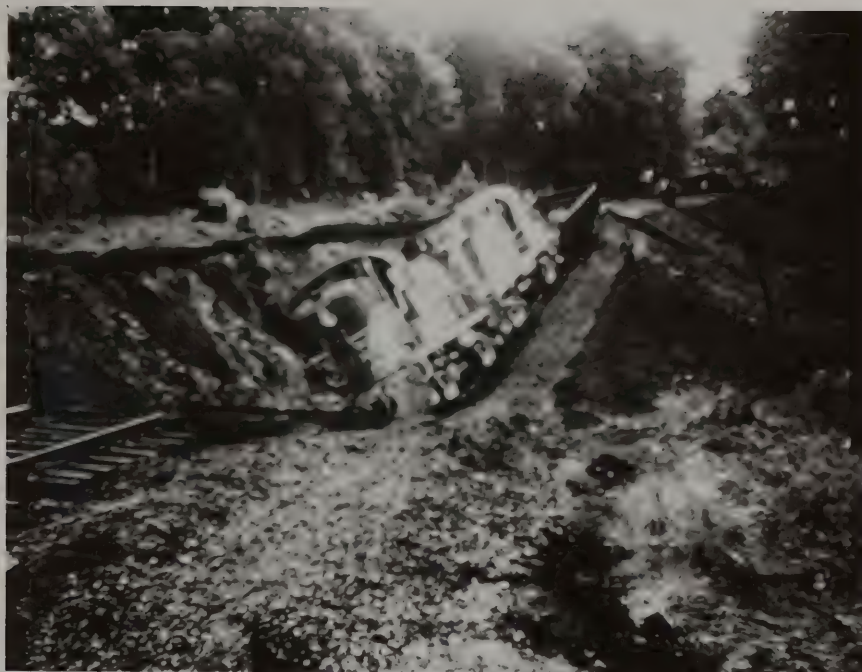
FIGURE 4

Figures 2 and 3. Figures 3 and 4 show the locomotives and the mudwave that exposed the lake bottom.

PHOTO OF EMBANKMENT FAILURE
D&H R.R. - SPAR MILL BAY, N.Y.
JUNE 1963

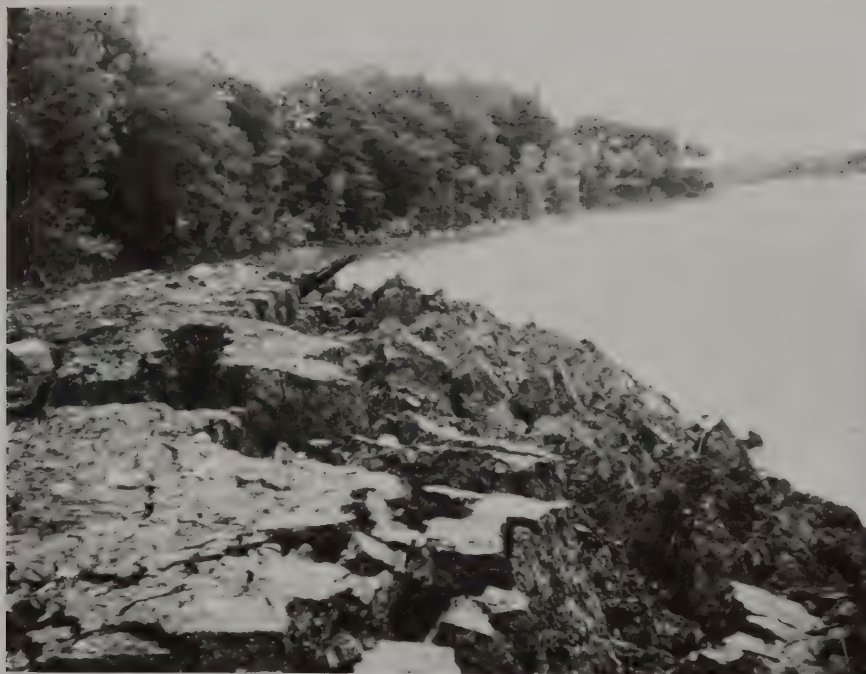
FIGURE 5

PHOTO OF MUDWAVE IN LAKE CHAMPLAIN
D&H R.R. EMBANKMENT FAILURE
SPAR MILL BAY, N.Y.
JUNE 1963

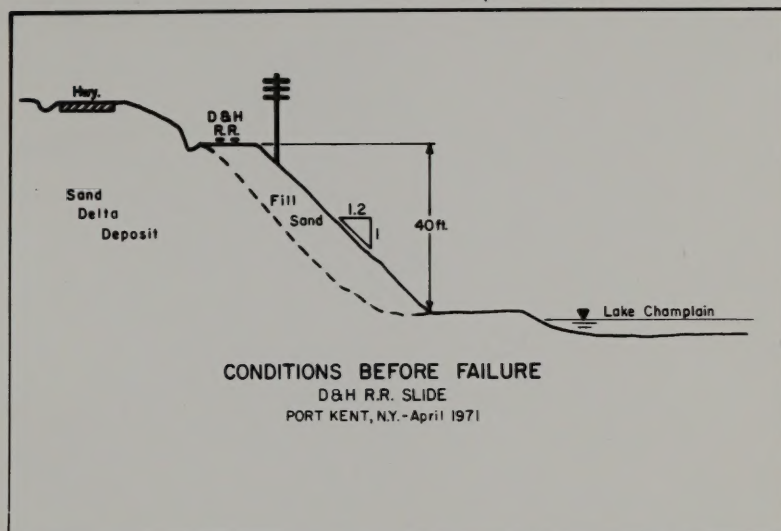
FIGURE 6

At another location further north at Port Kent a major failure occurred in the spring of 1971. At this location the roadbed is on a side hill fill 40 feet above Lake Champlain as shown in Figure 5. The embankment was constructed 50 years ago against the face of a delta deposit of sand laid

Suddenly, during the spring thaw, a portion of the fill literally became liquified and slumped into the lake. Railroad maintenance forces placed emergency fill but this material also became unstable and flowed into the lake.

SECTION SHOWING CONDITIONS
BEFORE FAILURE
D&H R.R. SLIDE, PORT KENT, N.Y.
APRIL 1971

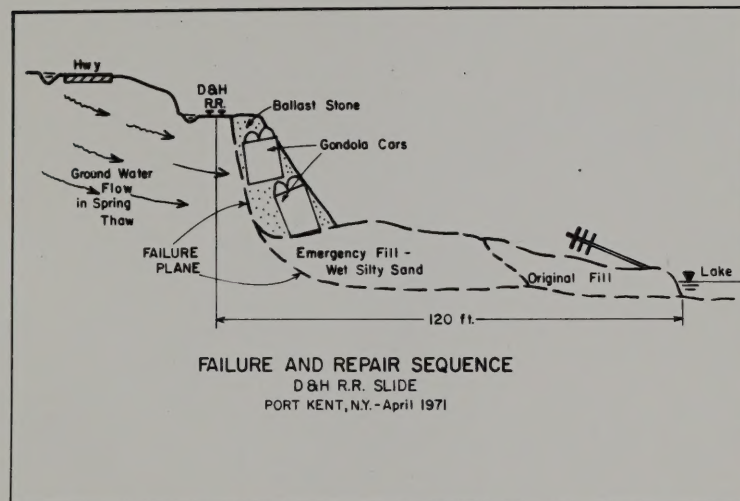
FIGURE 7

SECTION SHOWING FAILURE AND
REPAIR SEQUENCE
D&H R.R. SLIDE
PORT KENT, N.Y.
APRIL 1971

NYS DOT soils engineers were requested to provide recommendations for stabilizing this failure of the mainline embankment. Examination of the site indicated groundwater was emerging from the slide face. This groundwater flow must have increased significantly immediately before the failure since the winter frost had just become completely thawed and accumulated surface groundwater was able to flow downward into the delta deposit. The natural subsurface drainage direction in the deposit was toward the lake. The embankment had less permeability than the natural deposit and the groundwater head and seepage forces caused the fill to become unstable at its steep angle of repose resulting in the failure. It was decided that the best solution was to reconstruct the embankment with a pervious material to allow drainage and a lightweight material to reduce the load on the unstable fill previously placed. Readily available materials were ballast stone to provide permeability and a number of old gondola car bodies to decrease the embankment weight. The embankment was constructed to grade with the cars upside down as shown in Figure 6. The mainline was open to traffic in two days and the embankment has been stable since construction.
